# The Damaging Earthquake of 9 October 859 in Kairouan (Tunisia): Evidence from Historical and Archeoseismological Investigations

The city of Kairouan, the capital of the Aghlabides Dynasty (A.D. 800–909), and its surrounding areas were affected by a damaging earthquake on 8 Rajab 245 Hijri (9 October 859). Contemporaneous accounts by local travelers to the Abassides Califat (A.D. 750–1258) and reported by the chroniclers and historians [Al Baghdadi \(1980\)](#) and [Al Tabari \(A.D. 838–923\) \(1967\)](#) describe the damage to the city and report that 13 villages experienced extensive destruction, leading to a large number of people homeless. In the city of Kairouan, the dome and other holy places of the Great Mosque (minbar and mihrab), houses, fortifications, and bridges all suffered severe damage. The aqueduct that supplied Kairouan with fresh water from the western mountains was badly damaged at a location about 20 km west of the city. New archaeoseismic field investigations of the aqueduct using laser scanning and radiocarbon dating characterize the damaged features. Recent field investigations in the region taking into account the construction types and the inferred damage

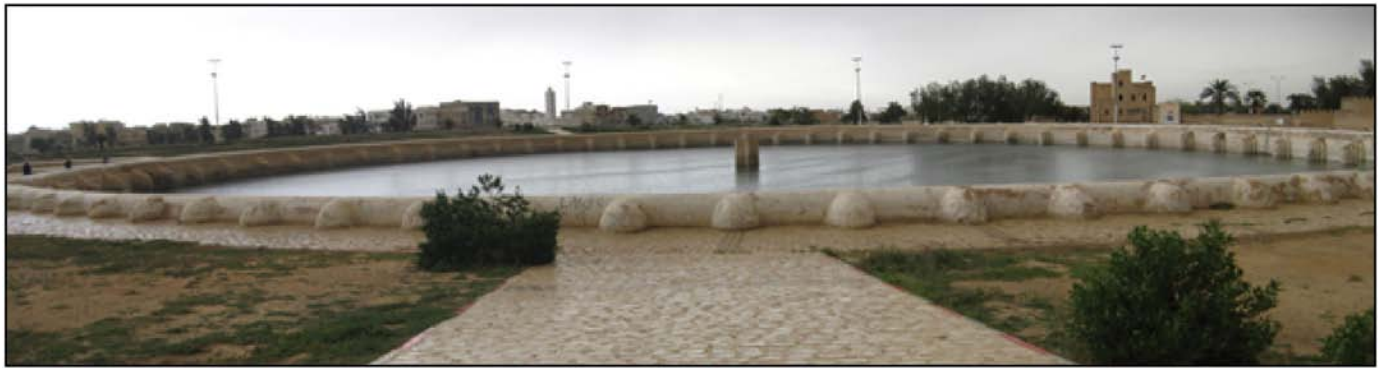
**Figure 3.** Open air cistern also called Feskiya of Bab Tunis in Kairouan. Water reservoirs like this were built in early A.D. 860 due to a water shortage. The diameter is almost 130 m, and it is about 5 m deep. The color version of this figure is available only in the electronic edition.

In A.D. 860 and the following years, the local governor Al Amir Abou Ibrahim Ahmed (who ruled Kairouan from A.D. 856 to 863) conducted important reconstruction and repair work in Kairouan and neighboring areas ([Solignac, 1952](#); [Mahfoudh et al., 2004](#)). As the city suffered from a severe shortage of fresh water in A.D. 860, probably due to the A.D. 859 earthquake and damage to the Cherichira Aqueduct, the local governor dedicated 300,000 dirhems (around € 700,000) to the construction of an open large circular water cistern (about 130 m in diameter and 5 m deep) for the city water supply, a historical masterwork also called “Feskiya” of Bab Tounes (Fig. 3; [Golvin, 1968](#)).

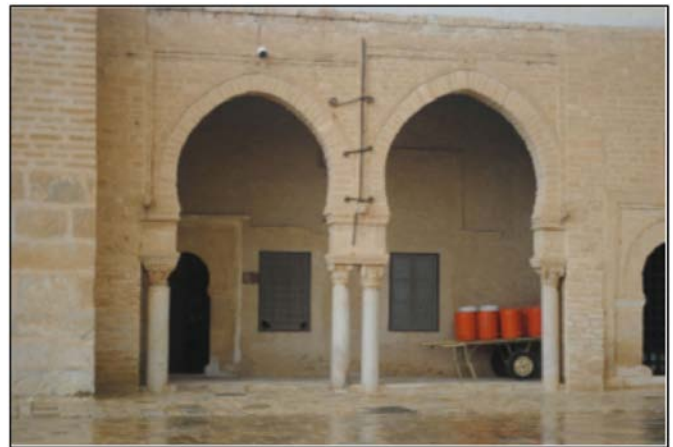
**Figure 4.** Two retrofitted arches in the Kairouan Great Mosque. The two retrofitted arches show different structures with the lower left structure and distorted right arch. Pillar tops are not at the same level, and the two structures are clamped with three iron hooks. The color version of this figure is available only in the electronic edition.

According to [Al Baghdadi \(\(1980\)](#), in the city of Kairouan the dome and other holy places (minbar and mihrab) of the Great Mosque, the houses, fortifications, and bridges suffered severe damage. [Golvin \(1968\)](#) reports on an observation of structural failure and related important repairs of the double arches in the nave of the Great Mosque from A.D. 862 to 864 (Figs. 4 and 5).

Although the Great Mosque was the object of several reconstructions and restorations ([Ibn Taghribirdi \[1411–1470\], 1963](#); [Golvin, 1968](#)), the most important reconstruction work (and in particular installation of the duplicate columns) was conducted from A.D. 860 to 863 by the local governor Ibrahim Ahmed. These duplicate columns are illustrated in a poster hanging in the Mosque that shows a significant and clear difference when compared to the previous Ziyadat Allah façade with its single column and small arches. The retrofitting of the Great Mosque can be observed in almost all pillars and arches surrounding the inner courtyard. Evidence of repaired damage is obvious near the minaret in the asymmetric arches and walls clamped with

iron hooks (Fig. 4). Replaced monolithic columns (made of limestone or granite), doubled since A.D. 860 ([Golvin, 1968](#)), show unusual shifts of height of the new columns that were often adapted with additional stone pieces (Fig. 5a–d).

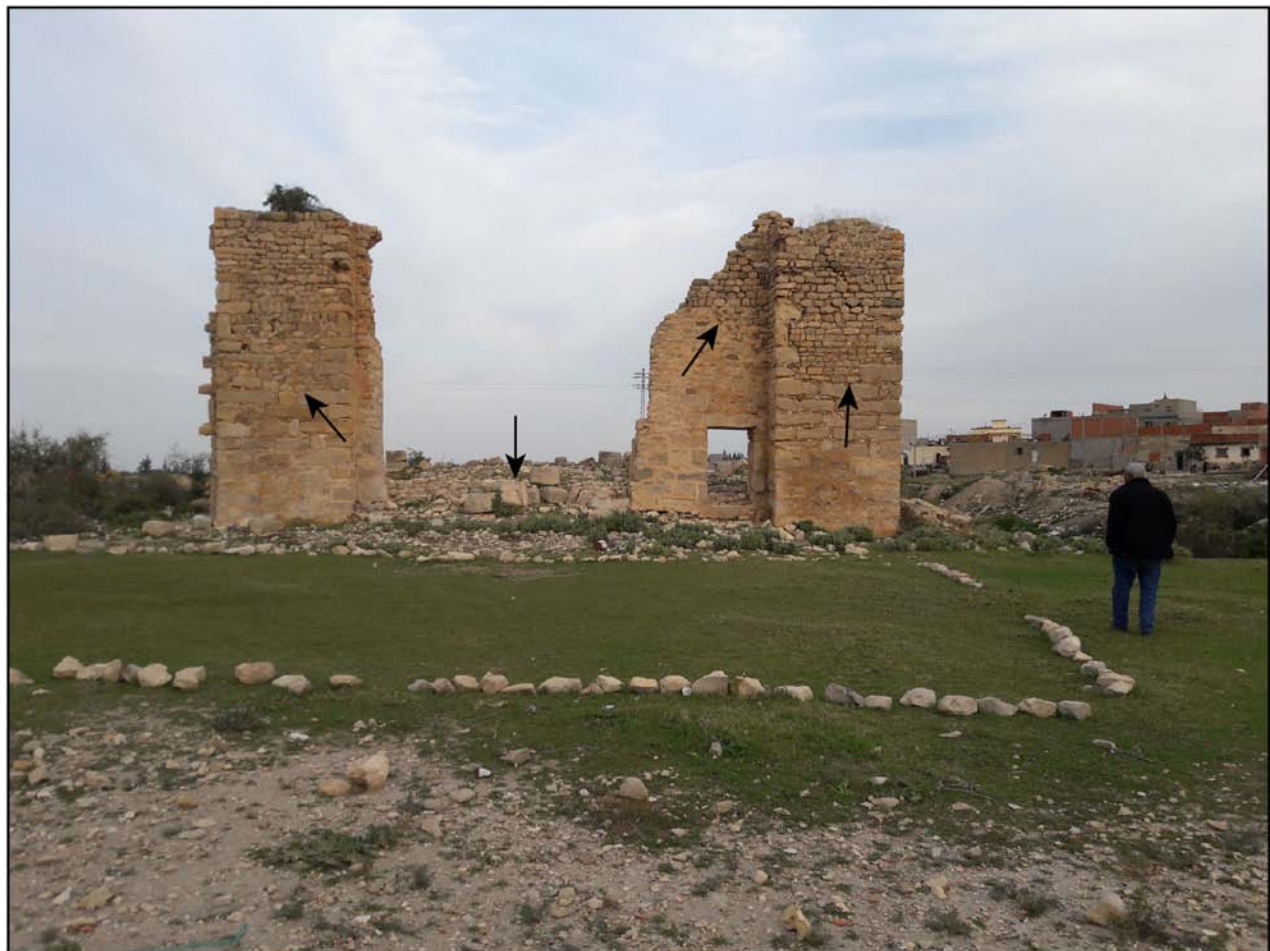
**Figure 6.** Damaged Roman city of Cululis (now Ain JIoula, see location in Figs. 1 and 2a,b). Arrows on frontal wall show the different building stones with evidence of reconstructions and

possible repeated earthquake damage. The central arrow shows collapsed large blocks. The color version of this figure is available only in the electronic edition.

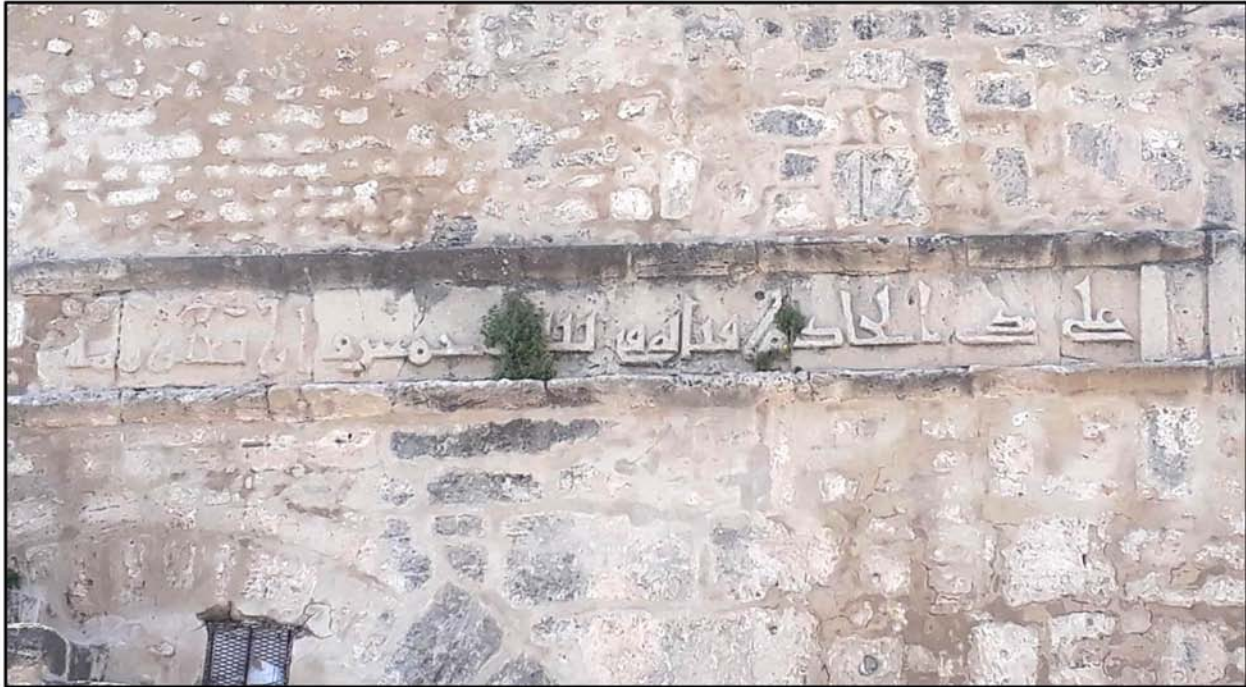
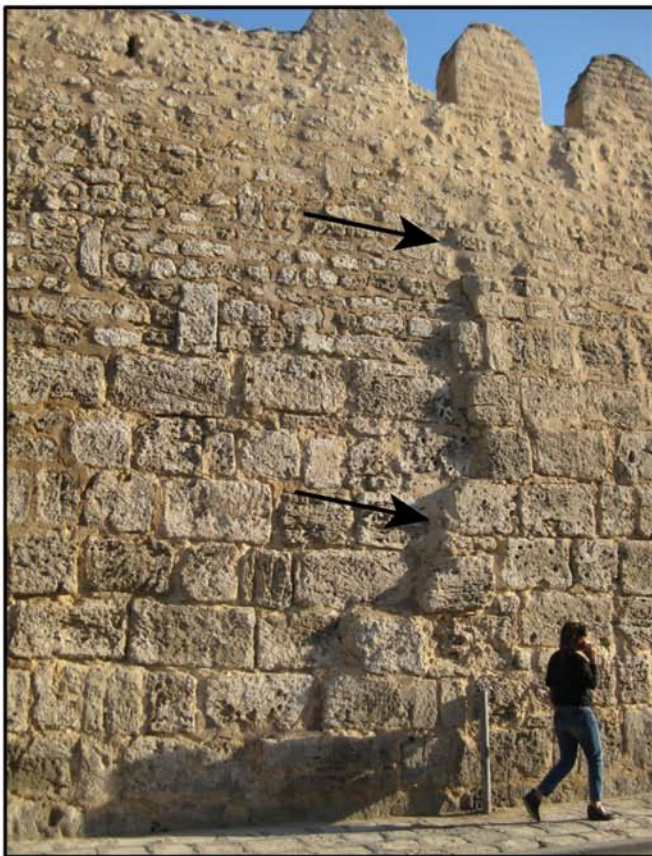
**Figure 7.** (a) Inscription “على يد الخادم فتاتة في سنة خمس وأربعين ومائتين” meaning “On behalf of the servant Fatata in the year 245H” that commemorates the reconstruction of the fortifications in A.D. 859–860 on the southern wall of the city of Sousse; (b) traces

(arrows) of repairs on the fortification wall of Sousse; and (c) repaired diagonal fracture (arrows) in a tower of the Sousse city fortification. The color version of this figure is available only in the electronic edition.

limits and reached as far as the coastal city of Sousse (ex. Justinianopolis, later on named Susa; Fig. 1). A still visible stone engraving on the Sousse city wall (in Arabic Coufi writing style) commemorates the reconstruction of the southern wall and related fortifications in A.D. 859 (Fig. 7; Laporte, 2015). Sousse being located about 40 km east of Kairouan (Fig. 1), the reconstruction of damaged fortifications (Fig. 7) immediately after the occurrence of the earthquake supports a large extent of the mesoseimal zone. Other important concomitant rebuilding of the lighthouse, mosque minarets, and battlements along with the retrofitting of old houses are all dated to have started in A.D. 859 (Laporte, 2015). The coincidence between the earthquake date and significant reconstructions in A.D. 860–863 indicates the severe level of seismic damage in A.D. 859. In comparison with other reported large earthquakes in central coastal Tunisia (Kharrat *et al.*, 2018), the size and extent of damage in the Kairouan region, 13 villages, and coastal Sousse suggest a maximum intensity of IX–X on the MSK macroseismic scale for the A.D. 859 earthquake.

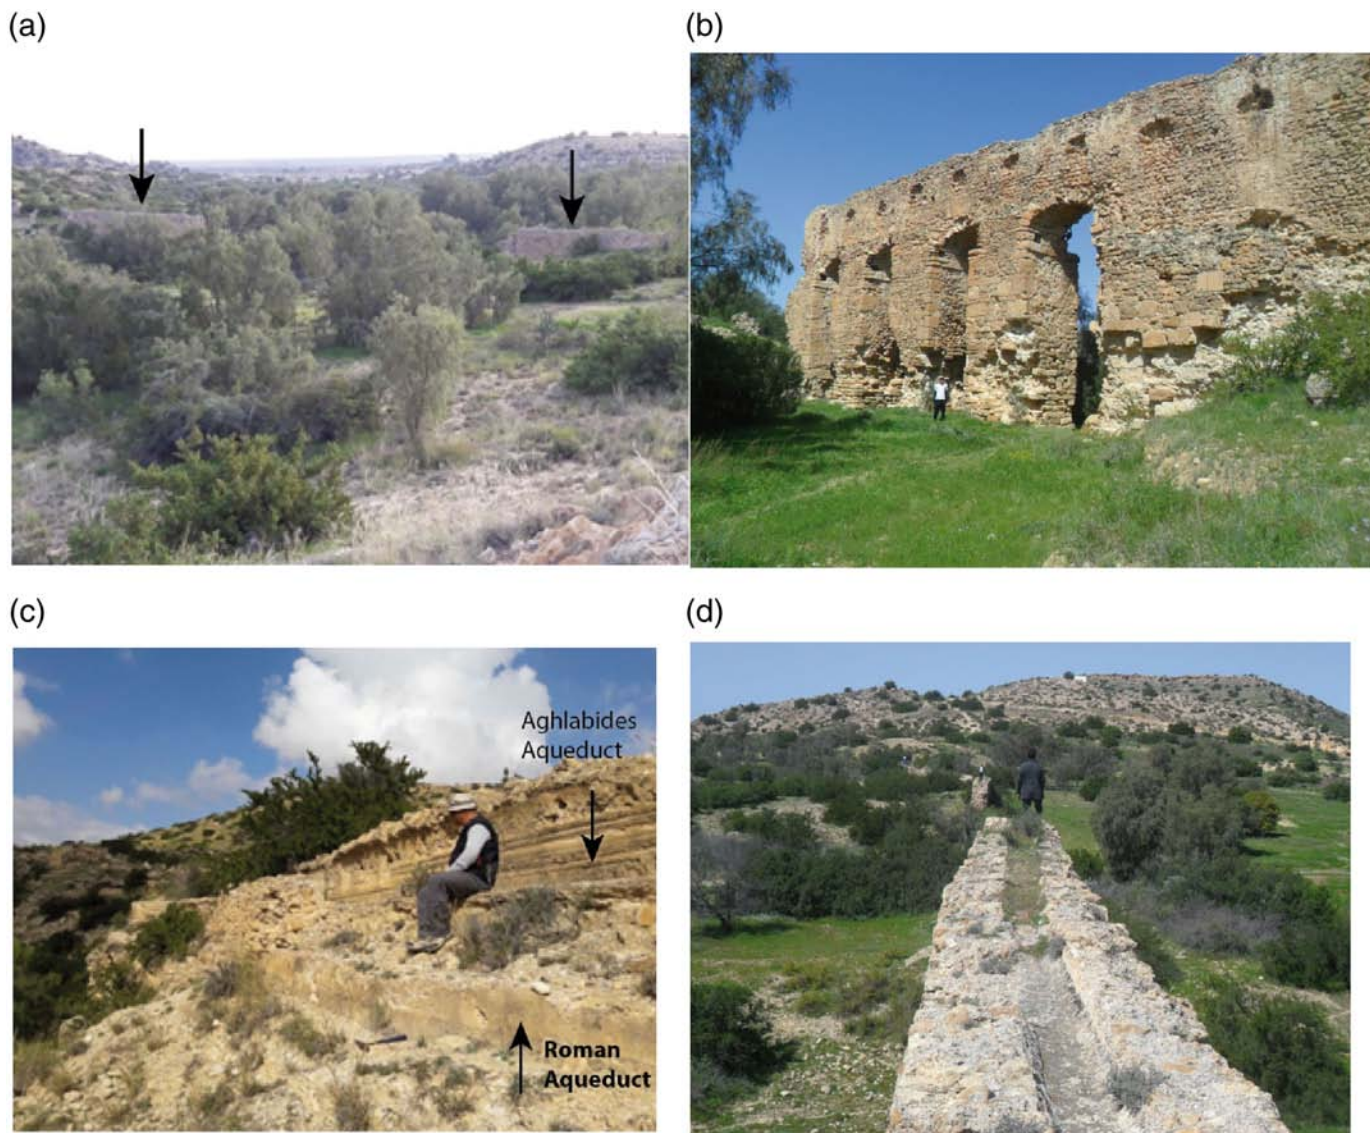
**Figure 8.** (a) The aqueduct bridge with its edges (arrows) crossing the Cherichira River; (b) ~25-meter-high aqueduct bridge with 2.9 × 2.9 m pillars built during the Roman time in Tunisia (146 B.C.–A.D. 423) and the Aghlabides period (A.D. 800–909); (c) the Roman and Aghlabides Aqueduct exposures; and (d) top of the aqueduct with a canal on the bridge. The color version of this figure is available only in the electronic edition.

The water supply to major cities in medieval times was an important factor of urban development. The city of Kairouan reached about 100,000 inhabitants in the ninth century and needed a constant access to fresh water (Mahfoudh *et al.*, 2004). The Cherichira Aqueduct, a previously Roman structure, provided fresh water to Kairouan and surrounding fields from Jebel Oueslet, located ~35 km west and northwest (Fig. 2b). The existing structure shows in some sections two main superposed canals, the first being Roman and the second Aghlabides (Fig. 8c). The aqueduct has a typical Roman design;

it is either buried, embedded or carved into geological units, or built upon the ground, and also is elevated as a bridge when crossing the ~170-meter-wide Cherichira River valley (Figs. 2b and 8a,b). The ~400-meter-long bridge reaches about 25 m high with basement stones ~1 m long, over ~0.5 m wide and height forming  $2.9 \times 2.9$  m (equivalent to 2 *passus* in Roman measures) size pillars (Fig. 8b). The northern half of the aqueduct bridge is damaged and collapsed where it crosses the valley, leaving the two edges quasi unbroken. Often located upon the Roman structure, the Aghlabides canal can be easily identified with its ~1-meter-high arched mortar edges (Fig. 8a–d).
